# Manhole Inspection Summary

Manhole # S23EE\_044MH

**Location** Address: **1306 CAREY ST**

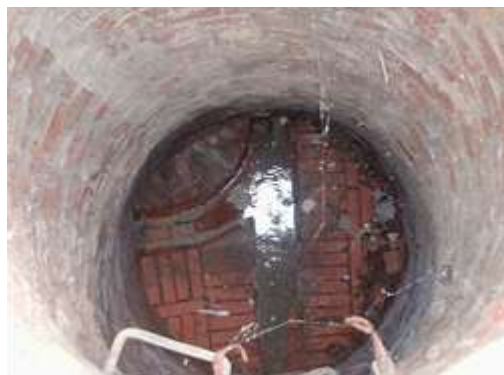
Top View

Corroded and missing steps. Evidence of surcharge - Bench debris. Channel debris.

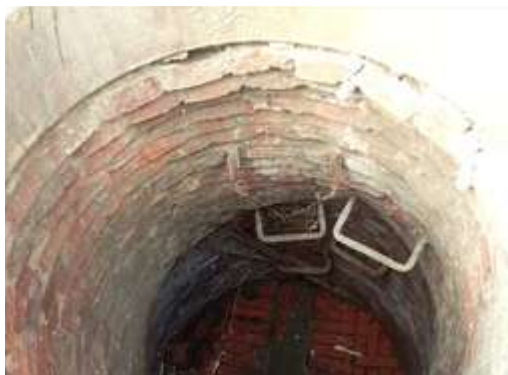
Defect

Frame leaks. Adjustment deterioration and infiltration. Corbel and Barrel infiltration.

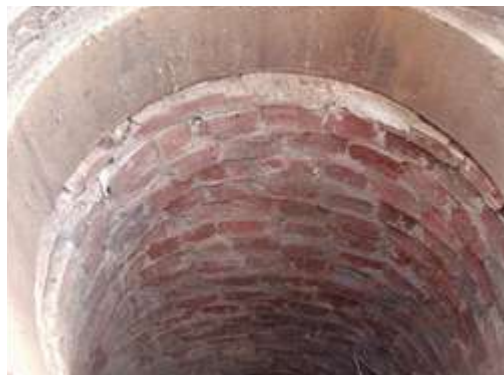
Defect

Frame leaks. Adjustment deterioration and infiltration. Corbel and Barrel infiltration.

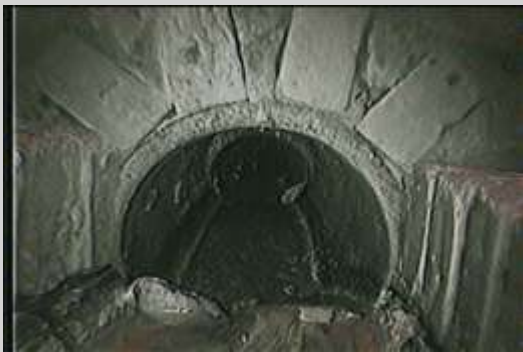
### 8 in. Circular Gravity Sewer Pipe Out @ 12 O'Clock

Deposits: ☐ None ☒ **Mud** ☐ Sludge ☒ **Debris** ☐ Grease

Silt Depth: **1** (in.) Deposits Extent: **Light**

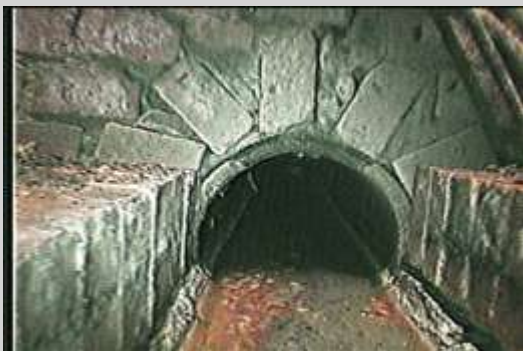
### 8 in. Circular Gravity Sewer Pipe In @ 6 O'Clock

Barrel deterioration and infiltration. Channel deterioration.

Deposits: ☐ None ☒ **Mud** ☐ Sludge ☒ **Debris** ☒ **Grease**

Infiltration: **Evidence** Pipe Seal Cond: **Broken**

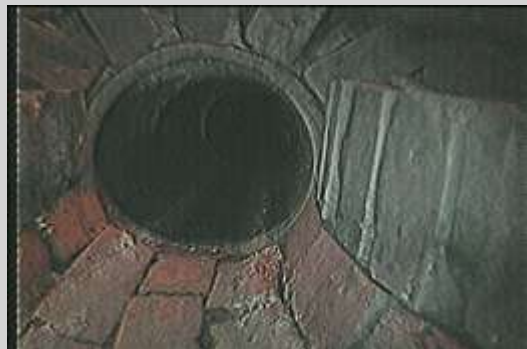
Pipe In @ 9 O'Clock

Barrel deterioration and infiltration. Channel deterioration.

Infiltration: **Evidence**

Pipe Seal Cond: **Cracked**
